Airworthiness Directive
1993-001/3

L 'Hotellier ball and socket connectors

Subject: L 'Hotellier ball and socket connectors with lock plates if installed in sailplanes, powered sailplanes and aeroplanes

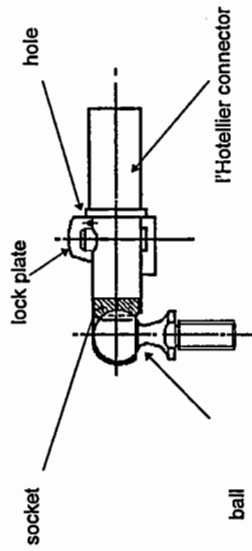
Section I

L'Hotellier ball and socket connectors with lock plate

Unsecured ball and socket connectors may open automatically in flight!

If the connectors are not yet equipped with safety pins (e.g. FH 140-31 made by Hotellier), these safety pins have to be retrofitted. In certain cases it may become necessary to bore the hole in the lock plate, which is provided for visual inspection, to \varnothing 1.2 mm so that the safety pin can be inserted.

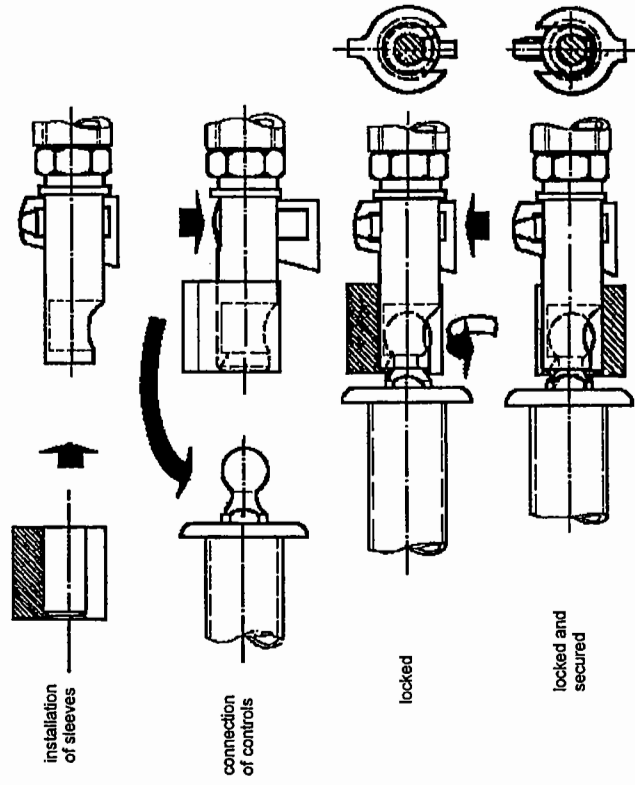
Section III

For installation, the sleeves have to be slid axially onto the l'Hotellier ball and socket connectors. They may by no means be clipped radially onto the l'Hotellier ball and socket connector. Radial clipping (excessive opening of the sleeve) may lead to cracks or ruptures due to overstressing so that the sleeve cannot function properly any more.

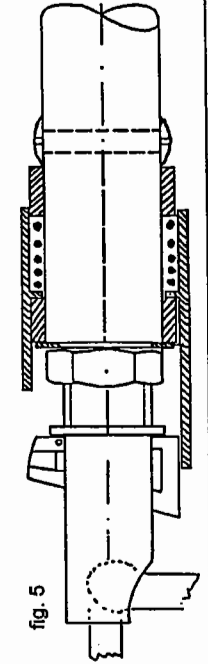
Section II

The following systems to secure l'Hotellier ball and socket connectors are LBA-approved: Uerlings sleeves or Uerlings type sleeves (see section III), safety pin (figures 2 and 2a), LS-safety sleeve (figure 3), Schempp-Hirth spring (figure 4) und Wedekind locking system (figure 5).

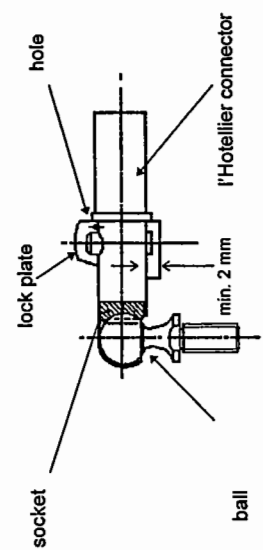
Section IV

The socket is to be slid completely over the ball with the lock plate pressed down. During locking the lock plate moves back slightly so that in a correct connection the hole on the narrow edge of the lock plate becomes visible.

Unsecured ball and socket connectors may open automatically in flight.

The safety pin is to be inserted in this hole thus securing the ball and socket connector.

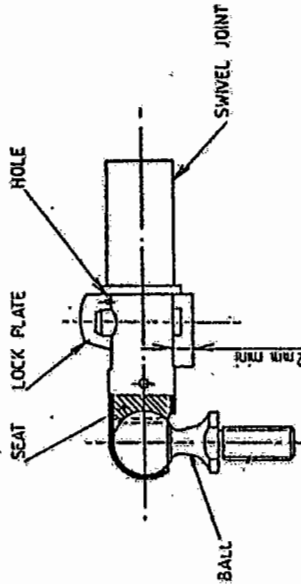
FIG. 1

2.5. MEASUREMENT OF THE LOCKER LOWER PART PROJECTION AFTER ASSEMBLY OF THE SWIVEL ON THE BALL (see fig. 1)

This projection must be higher than 2 mm.
The aim of this requirement is to verify the efficiency of the automatic take up clearance

If after these verifications, one of the above check is out of tolerance, it is mandatory to replace both ball and swivel.
nevertheless it is recommended to replace this assembly every 10 years or every 3000 flight hours.
