Kind : LBA Airworthiness Directive AD-Note no. 78 -

Subject : Safety measures for inspection hole cover in fuselage.

Effectivity : All ASW 20s. serial numbers 20 001 through 20113, except 20111.

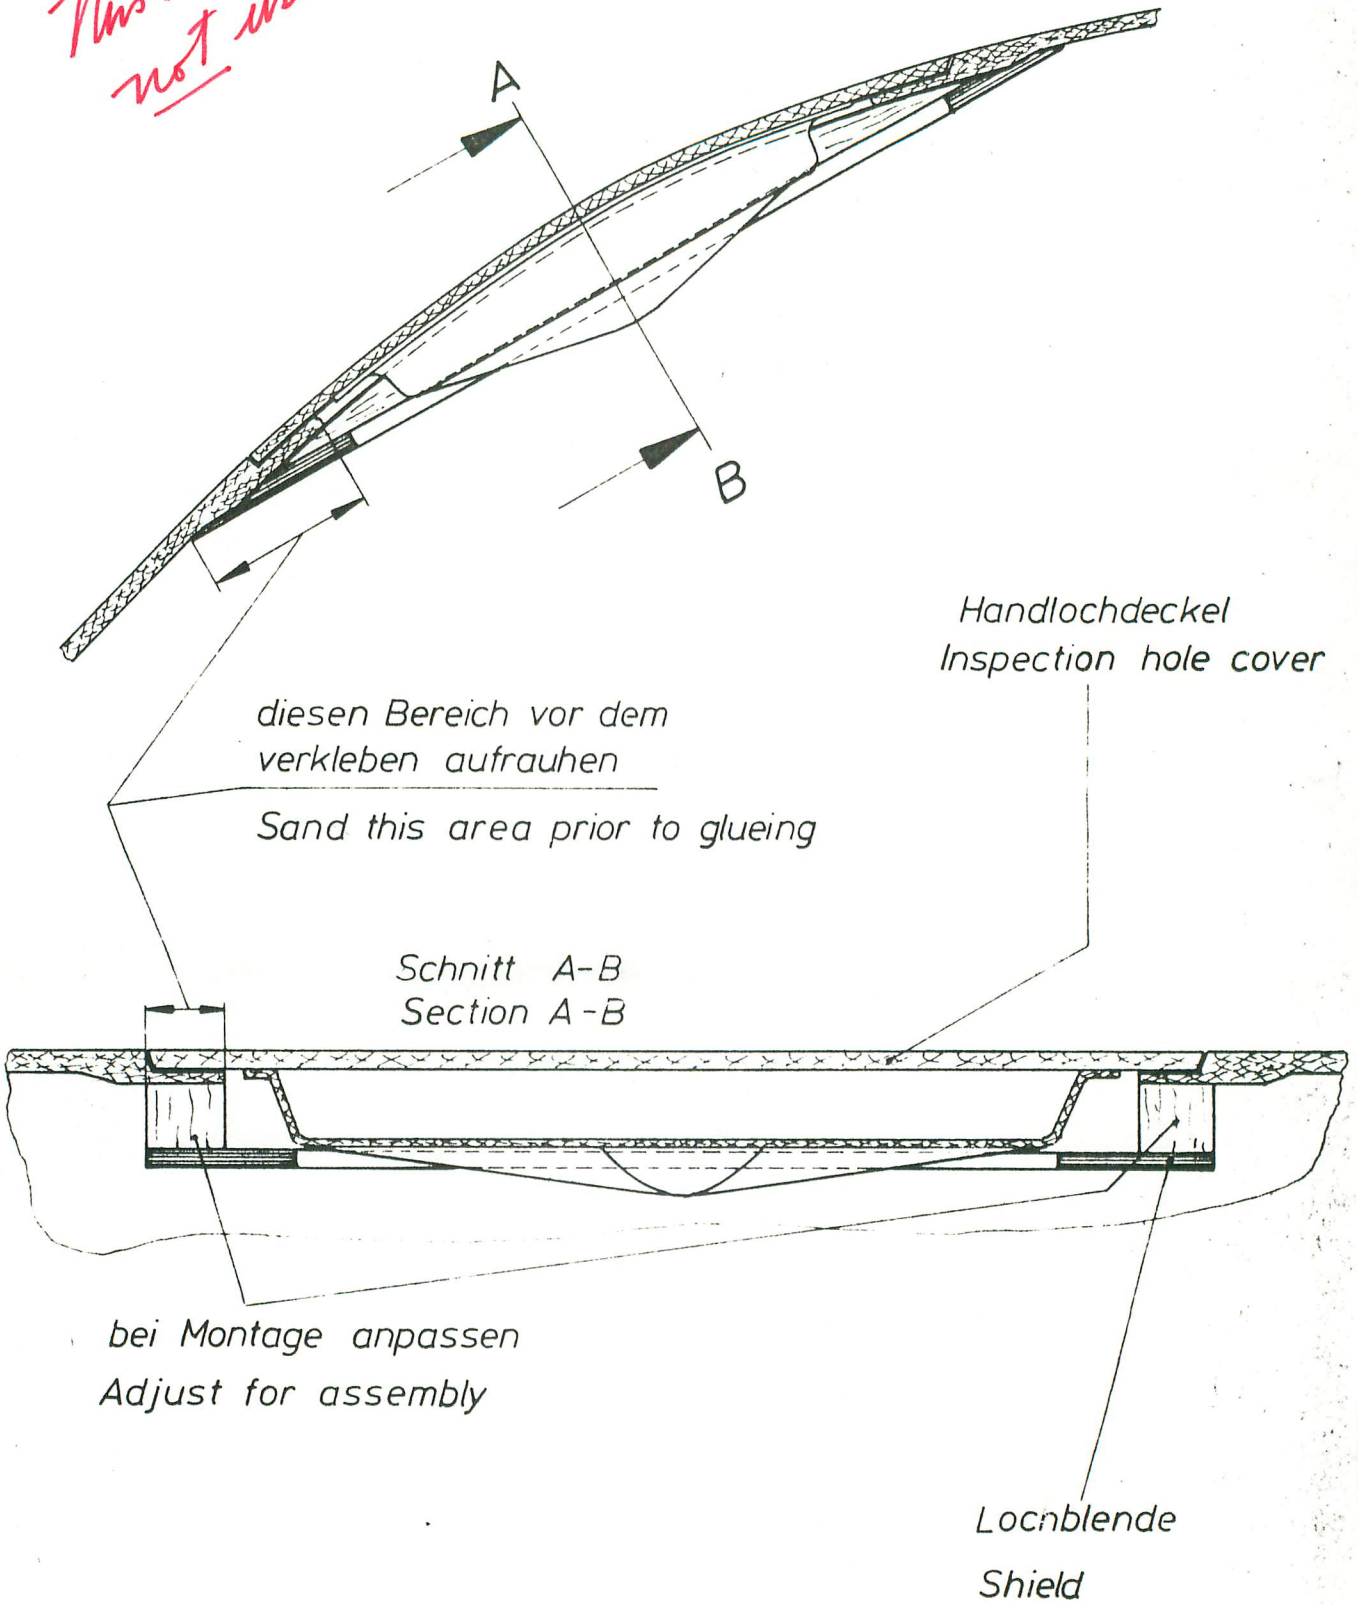
Reason : During a cross country flight with an ASW 20 the inspection hole cover which was not taped was lifted up during a pullup into a strong thermal and was, subsequently, pulled into the fuselage by the attached bungee. There it jammed temporarily the aileron and flap control.

Instructions : TN 4a :
By means of a plywood ring shield (P/N 200.11.0127) the hole of which is narrower than the smallest width of the inspection hole cover it is prevented that the cover can get into the fuselage.

For the cover itself or the bungee no modification is necessary.
See drawing on sheet 4 of this TN.
