Inspection of aileron weight and aileron c.g. and inspection of play (backlash) in aileron and flap control circuits to avoid flutter risk.

Glider model ASW 20, s/n 20 001 thru 20077 and 20 086.

Poppenhausen, February 17, 1981

ALEXANDER SCHLEICHER
Segelflugzeugbau

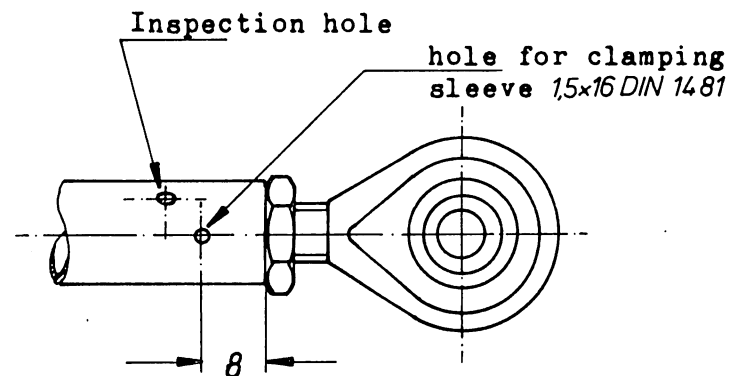
4. Please check if the lever at the mixer is at the end of the track when the flap handle is locked in position 1 (-11°).
If the handle can be pushed past the hole of position 1, one of the spheric ball joints of the flap pushrod, which is found on the left cockpit wall, must be turned in to shorten the pushrod. This must be done until the flap handle can just be locked in position 1 as the end of the track in the mixer is now touched.
After adjustment both spheric ball joints must be safetied by 1,5mm clamping sleeves against being turned out (in addition to the nuts).

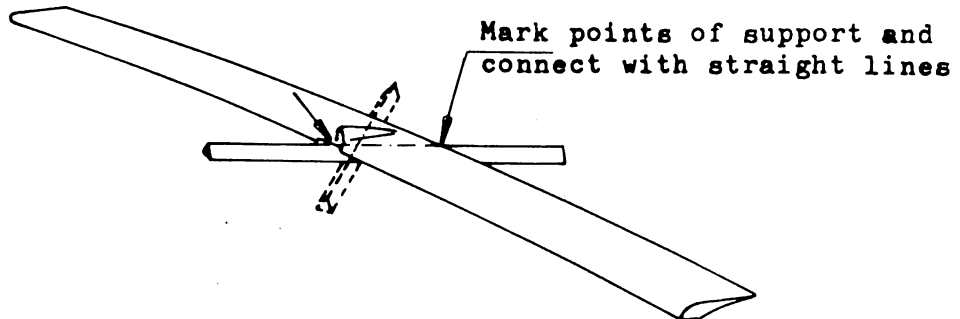
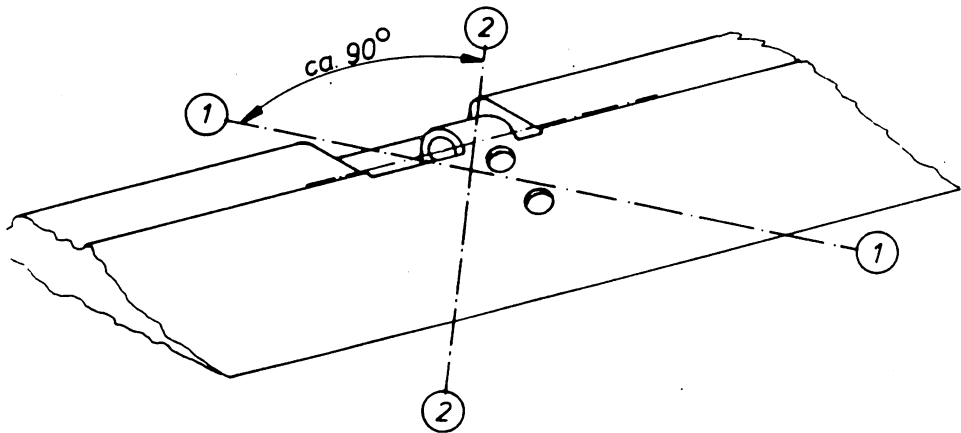
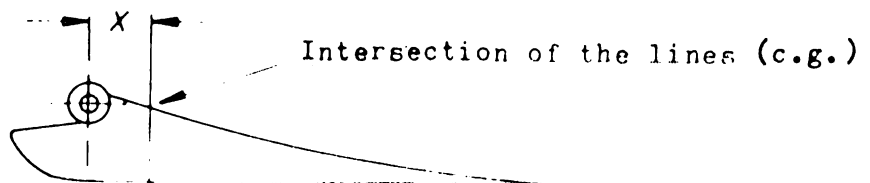
Determination of tailheavy moment of controls by balancing
on a cutting edge done twice (triangular strip)

Diverging from the sketch in the Manuals the c.g. of the ailerons is balanced according to the sketch on sheet 5 of this Technical Note. The weight of the aileron (if fittings have been removed, without their 0.07 kg) as determined multiplied by the distance from the c.g. to the hingeline is the tailheavy moment of the aileron. If the actuator fitting was removed, 0.15cmkg must be added. This total moment must not be greater than tolerated by the Manuals.

The connecting lines of the points of support ① - ① and ② - ② intersect in the c.g.

X = Distance from the c.g. to the center of the hingeline.

Weight (kg) · X (cm) = Moment (cmkg)
