REPAIR MANUAL

FOR SAILPLANES TYPE ASW 12, ASW 15, and ASW 17, ASW-20

Issued Winter, 1974

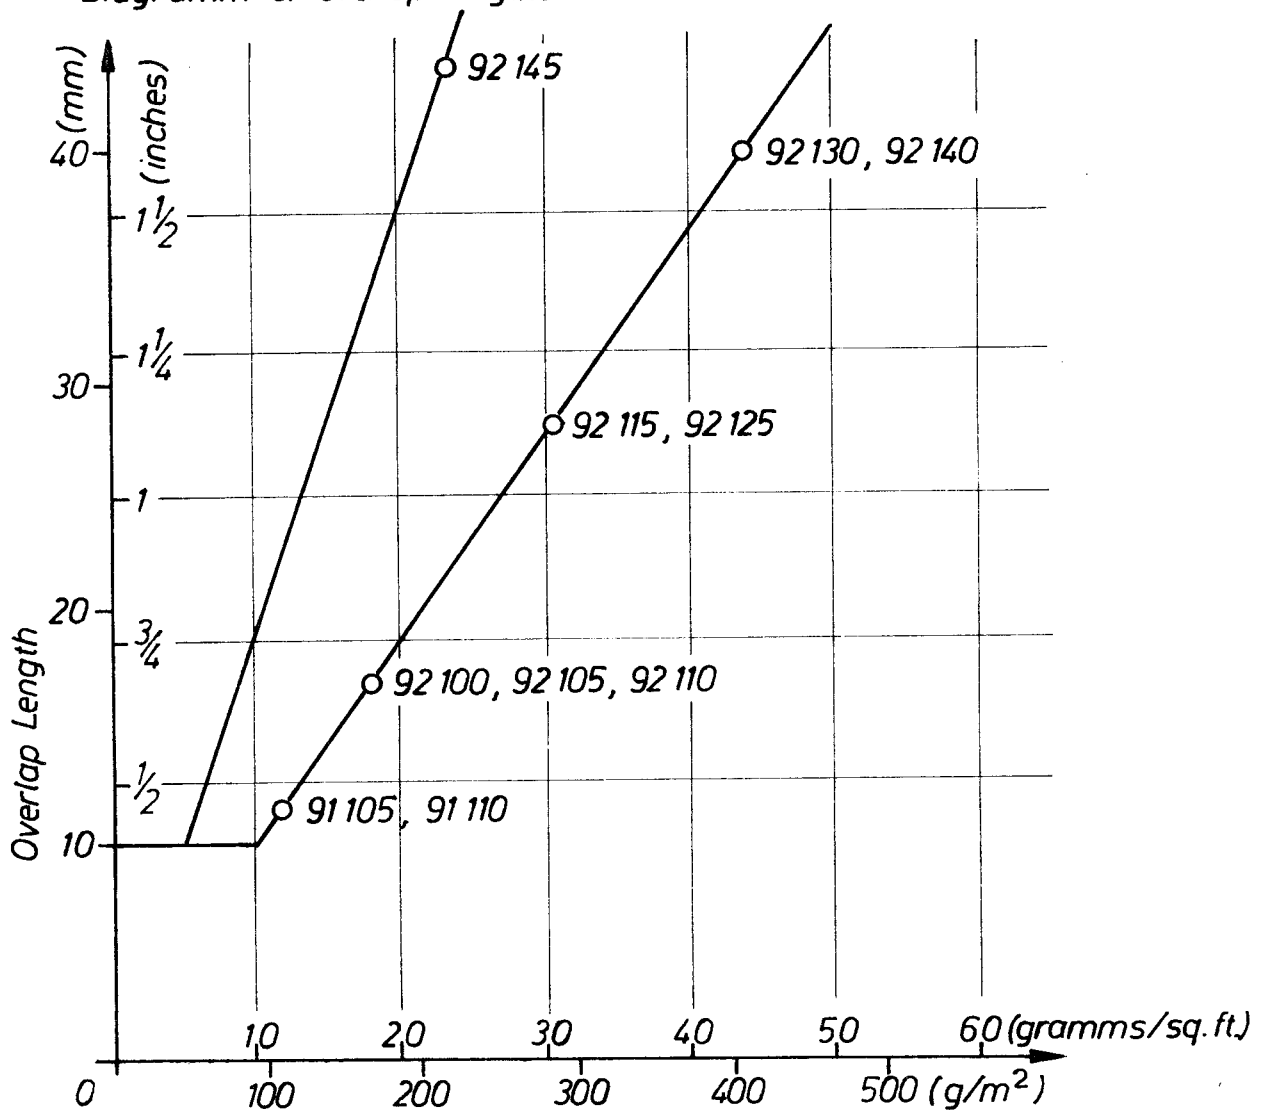
Diagramm of overlap lengths

Scarf joints can be half as long as overlap joints.

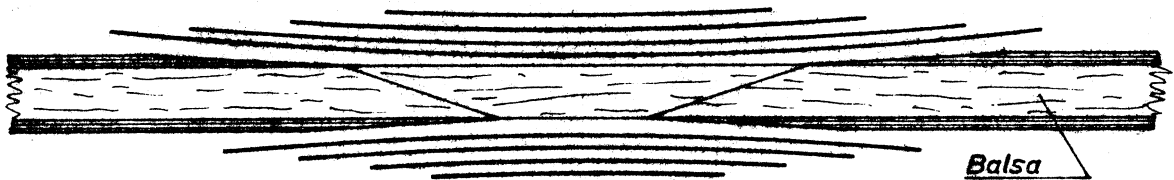
**Bild 2:** Reparatur der Klasse 2 (Innenseite zugänglich)  
**Fig. 2:** Repair of Class 2 (inside skin accessible)

Schaum od. Tubuskern  
Foam or Tubuscore

This covers the repair of components, where the complete sandwich structure has been damaged : Outer skin, supporting core, and inner skin. The first step is to cut out the damaged skins and balsa core. Again, only round or oval shaped cut-outs should be made. The cover layers receive a very flat scarf joint ( 1:50 to 1/100) by way of sanding with disc or sanding block; the supporting balsa core will be scarfed 1 : 5 in the direction of the grain. After the balsa core has been glued in, the fiberglass laminations will be applied as described in class 3. The best approach is to lay up and completely cure the skin on one side first, then to turn the component over and laminate the skin on the other side. In cases, where the inside of the sandwich is practically inaccessible, one must prepare the repair area as shown in picture no. 3.

Since the interior skins used in the ASW 12 sandwiches wings and control surfaces are as a rule rather thin, they cannot be scarfed, but must be lap jointed. This simplifies the repair somewhat, as one, therefore, does not need to scarf the inner skin. The fiberglass patches that make up the outer skin are prepared as described in class 3. The next step is to laminate the inner skin to the lower side of the balsa filler, allowing approx. 2 - 3 hours at 20 - 23° centigrade for the epoxy to gel. At this point freshly mixed epoxy is added to the glue joints of the balsa filler block and now the balsa block - with the prelaminated side to the bottom - is gently pressed in place. Finally, the exterior skin is layed up as described in class 3.

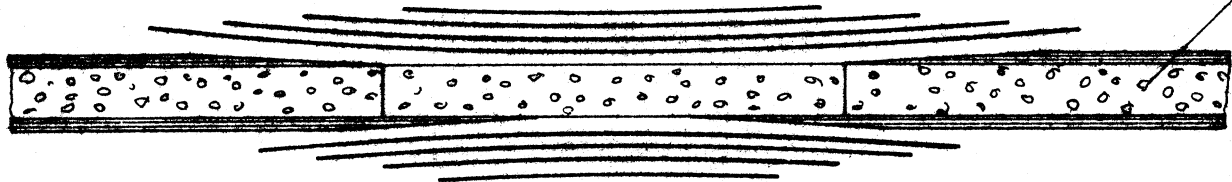
**Bild 3a:** Reparatur der Klasse 2 (Innenseite unzugänglich)  
**Fig. 3a:** Repair of Class 2 (inside skin inaccessible)

Vorbereitung der Reparaturstelle. - Preparation of the repair area.

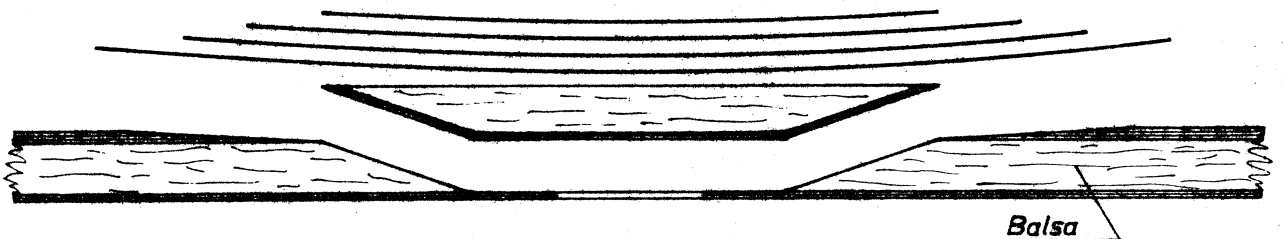
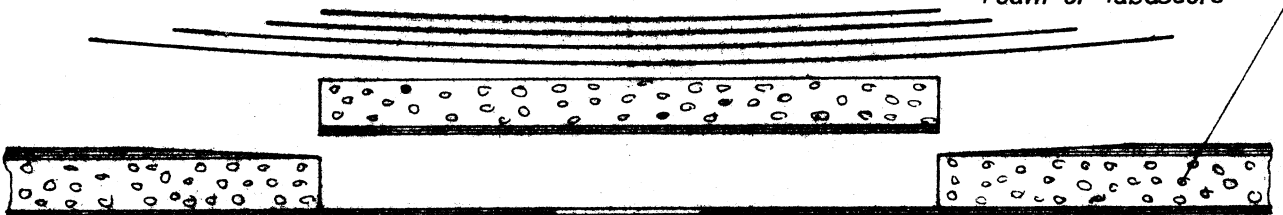
**Bild 3b:**  
**Fig. 3b:**

Schaum od. Tubuskern  
Foam or Tubuscore

Schäftungen sind stark verkürzt gezeichnet!  
All scarf joints are much shorter in these figures than they must be actually!

In situations, where there is a possibility of sag of the inner skin, especially when large area repairs are made, it will be advisable to support this inner skin with a slab of foam which has been glued in place prior to the actual repair. In case of inaccessible areas, this supporting foam will have to be left right inside the component.
